# Characterization of C/SiC Ceramic Matrix Composites (CMCs) with Novel Interface Fiber Coatings

Jeanne F. Petko, QSS Group, Inc., Cleveland, Ohio, USA

J. Douglas Kiser, NASA John H. Glenn Research Center at Lewis Field, Cleveland, Ohio, USA

# Characterization of C/SiC Ceramic Matrix **Composites With Novel Fiber Coatings**

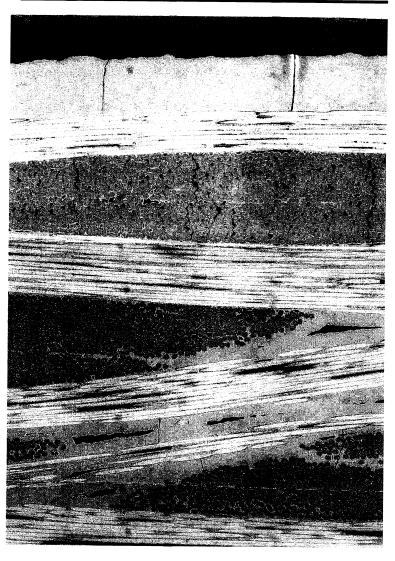
#### Microstructure of 2-D CVI C/SiC

- Utilizes T-300 fiber
- Plain weave (PW) fabric
- Pyrolytic carbon (PyC) interface
- 45 v/o fiber

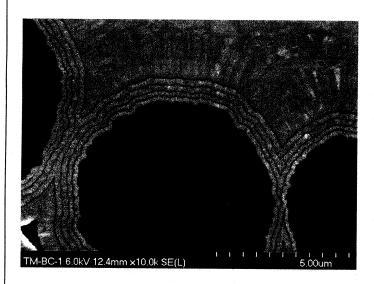
Surface of Composite, Surface of Tow

Fiber Coating: SiC with interspersed thin C layers, emulating unbonded SiC layers. Significant change in fiber coating thickness and appearance from surface of the composite to the interior.

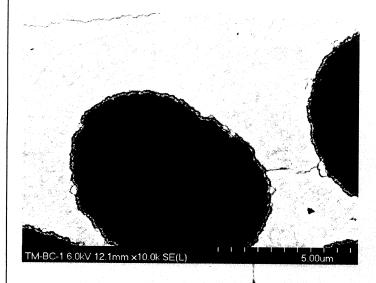
Center of Composite, Surface of Tow
